## VEHICLE INSPECTION REPORT

**WD73CBX**

### NISSAN INTERSTAR F35 2.3 dci 135ps

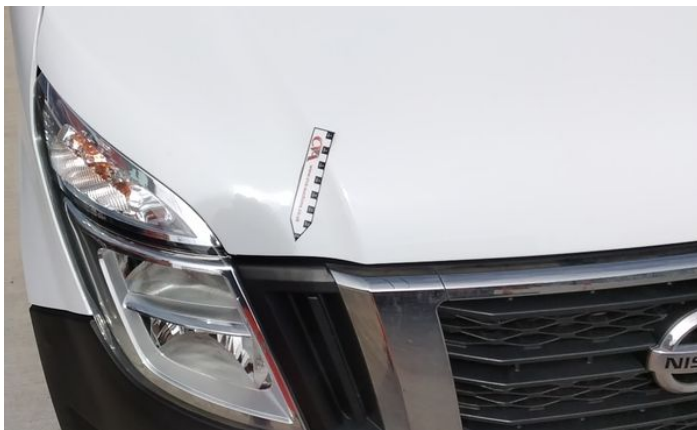
1: Bonnet  
Chipped  
Multiple Chips

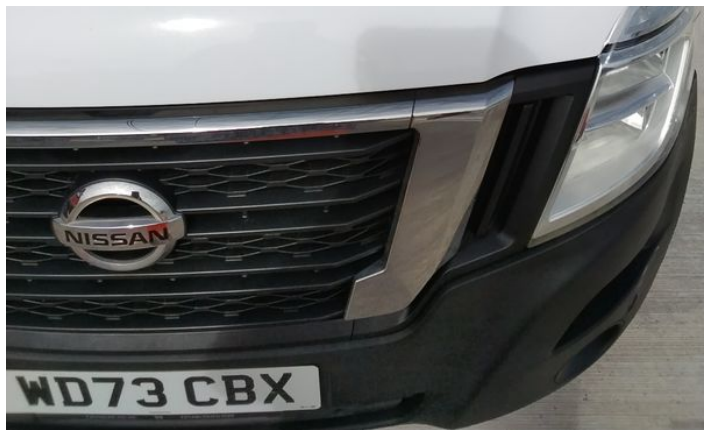
2: Bonnet  
Chipped  
Multiple Chips

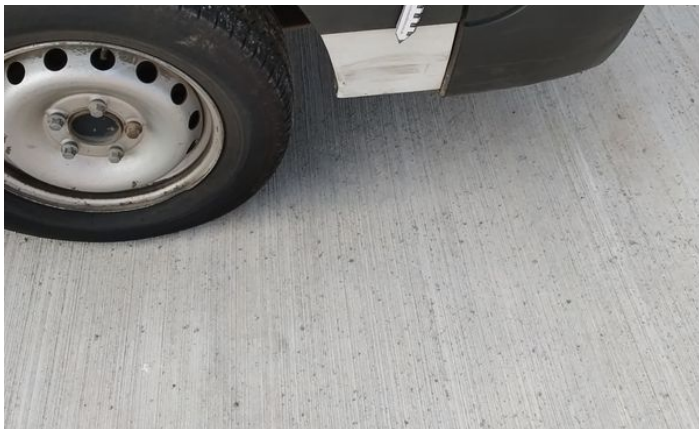
9: Qtr Panel nsr  
Dented  
Over 30mm

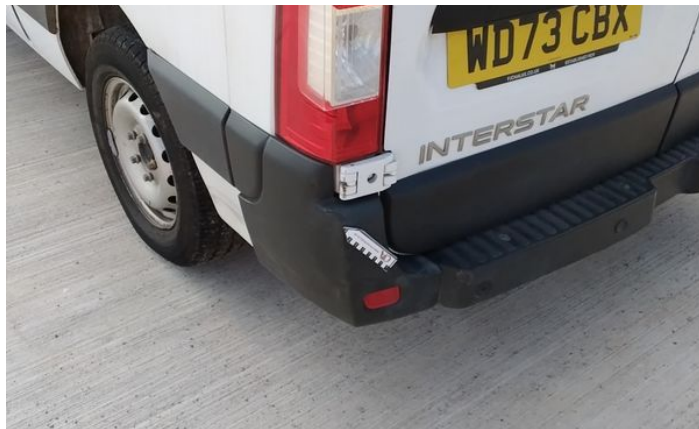
10: Bumper Rear Moulding  
Scuffed (Unpainted)  
Over 100mm

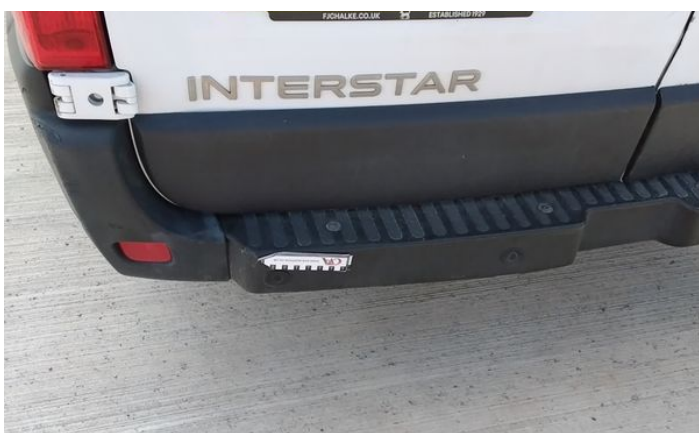
11: Bumper Rear  
Scratched  
Over 25mm Not Thru Paint

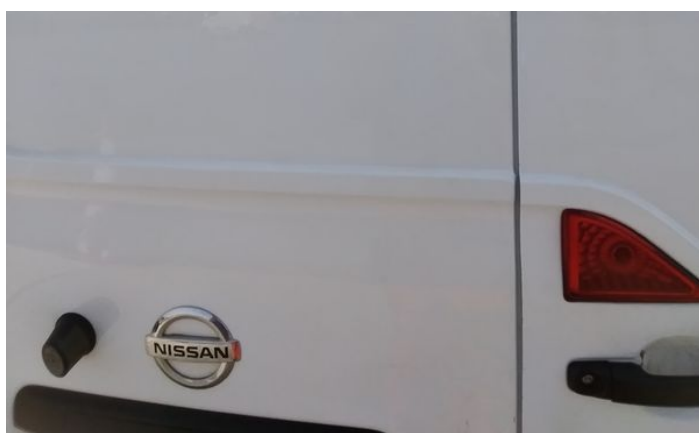
12: Door osr  
Chipped  
Multiple Chips

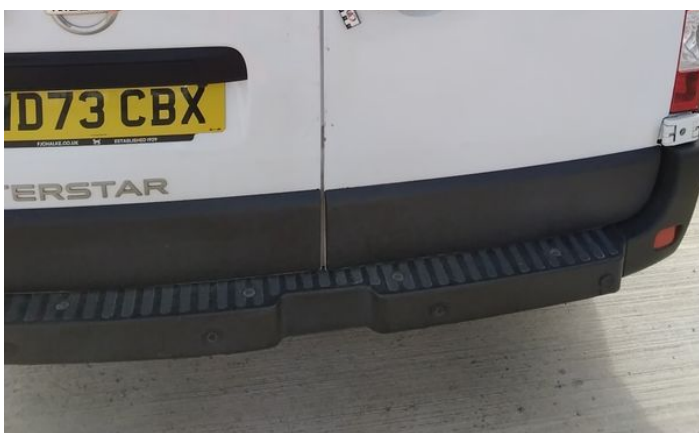
13: Door osr  
Chipped  
Edge Chip

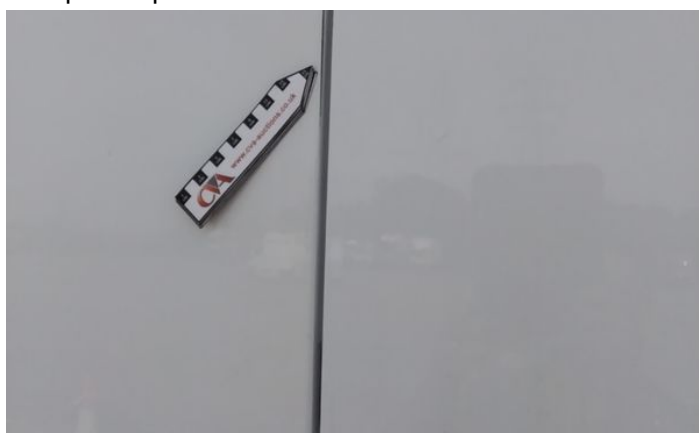
14: Door nsr  
Chipped  
Edge Chip
