# VEHICLE INSPECTION REPORT

**PO13EJF**

## Daf LF 55.220

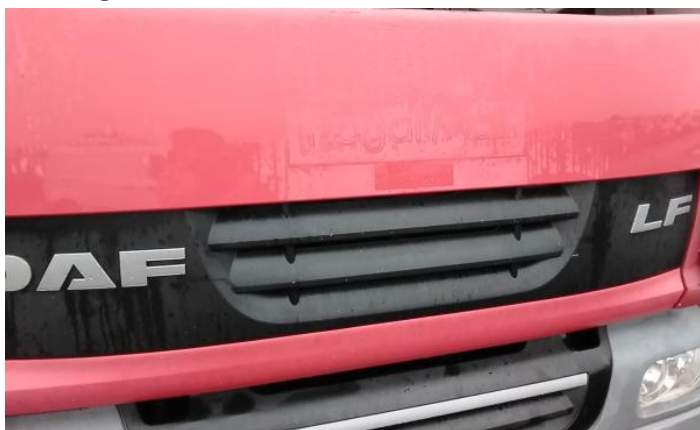
1: Bonnet  
Chipped  
Multiple Chips

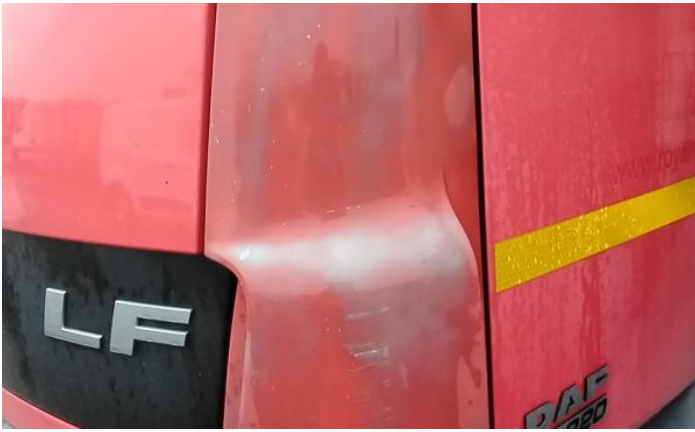
3: Panel Front  
Poor Previous Repair  
Poor Paint

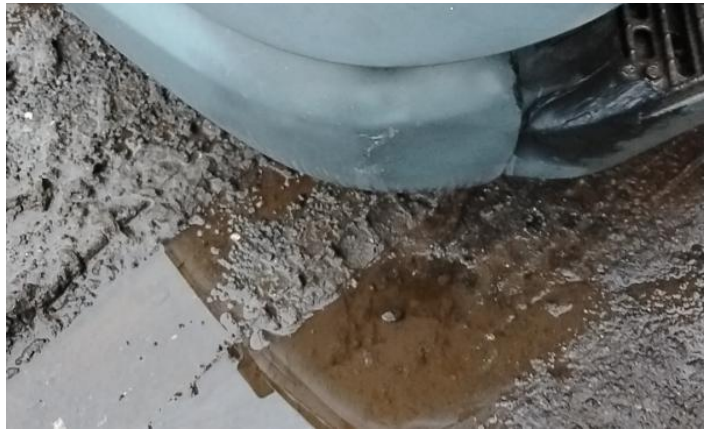
4: Bumper Front  
Dented  
With Paint Damage

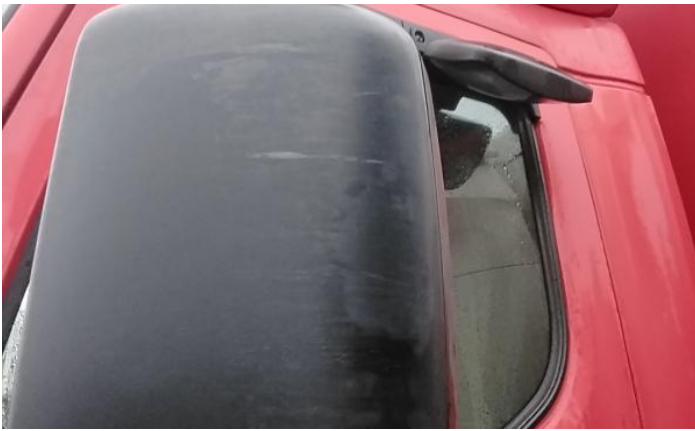
5: Door Mirror Assy nsf  
Scuffed (Unpainted)  
Over 100mm

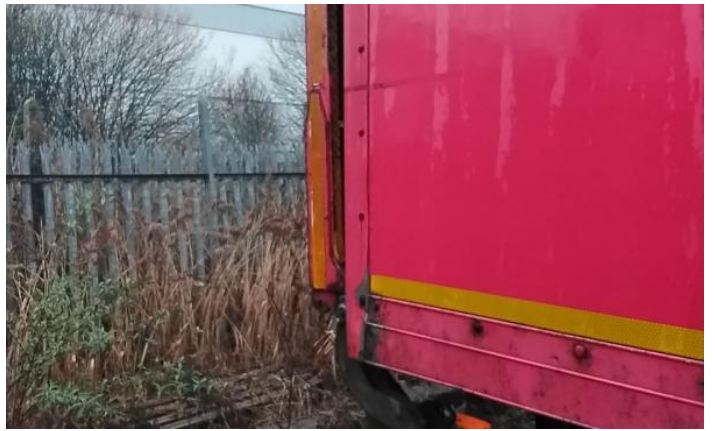
6: Qtr Panel osr  
Scratched  
Over 25mm Thru Paint

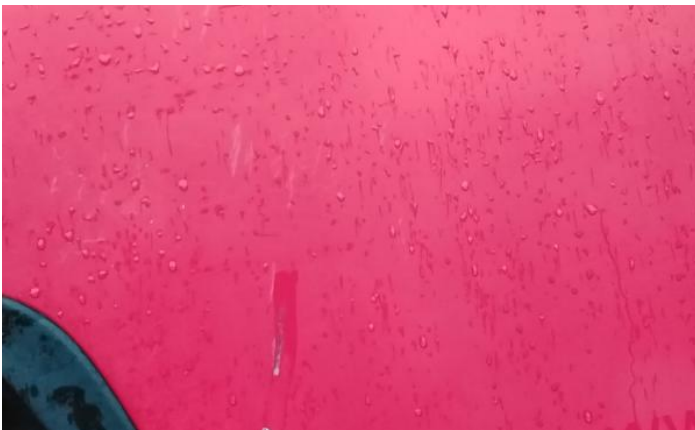
7: Door osf  
Scratched  
Over 25mm Thru Paint

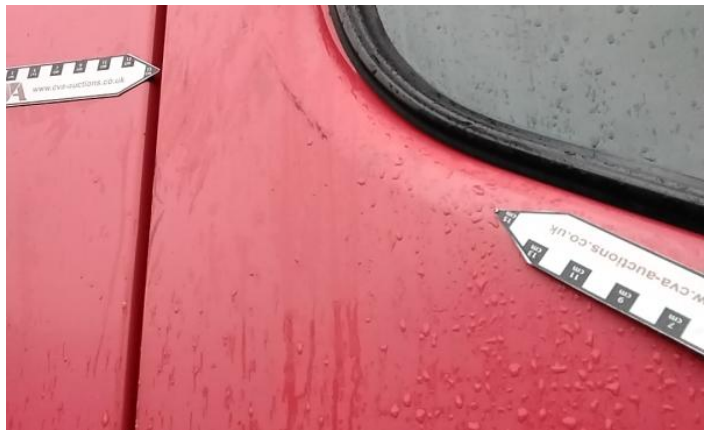
8: Door osf  
Scratched  
Over 25mm Not Thru Paint

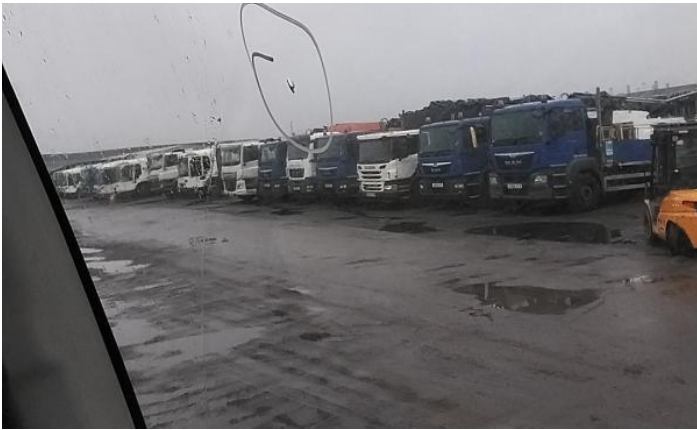
9: Screen Front  
Chipped  
Over 10mm

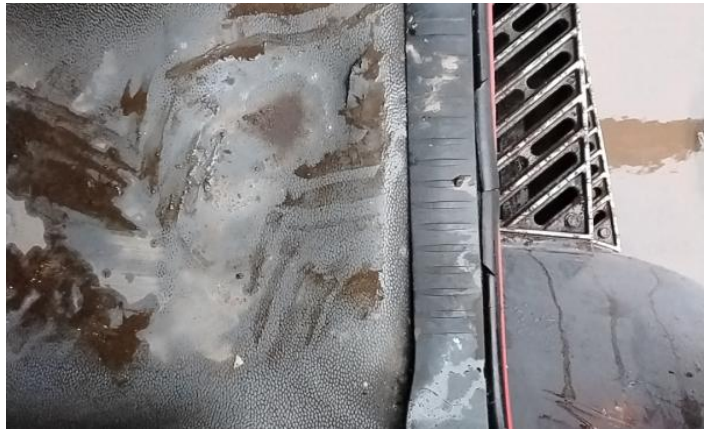
10: Carpets Front  
Torn  
Over 10mm

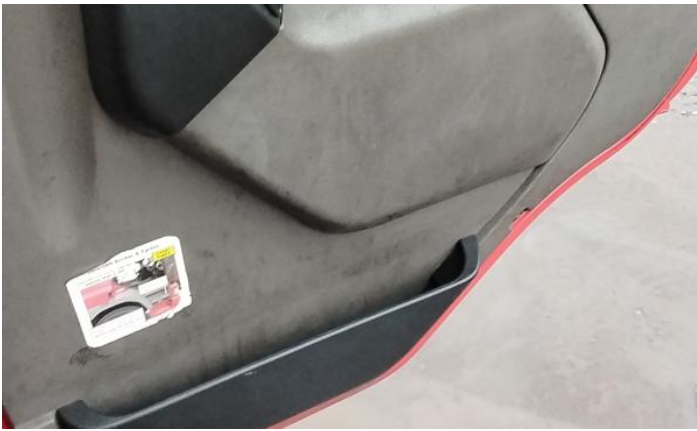
11: Door Pad osf  
Soiled  
Heavy
