# VEHICLE INSPECTION REPORT

**LN70XSK**

## Mercedes-Benz Antos

### Inspection

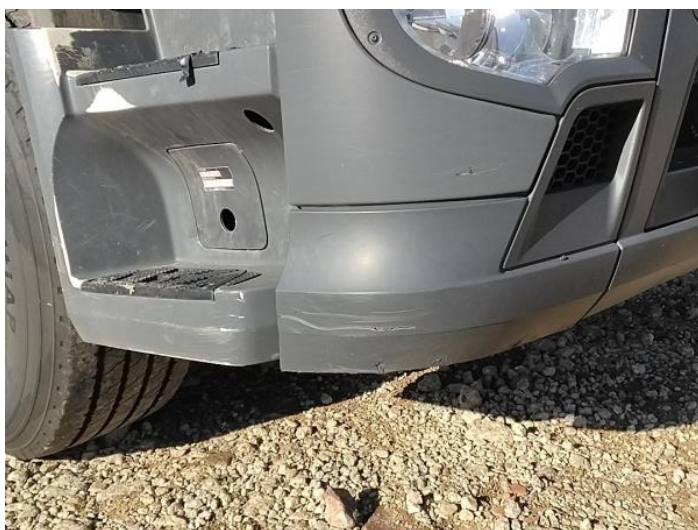
1: Bumper Front Moulding  
Scuffed (Unpainted)  
UpTo 100mm

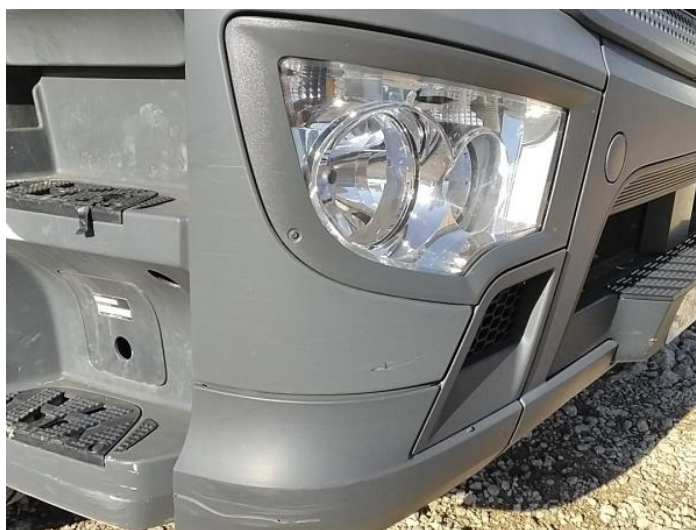
2: Fog Lamp Surround os  
Scuffed (Unpainted)  
UpTo 100mm

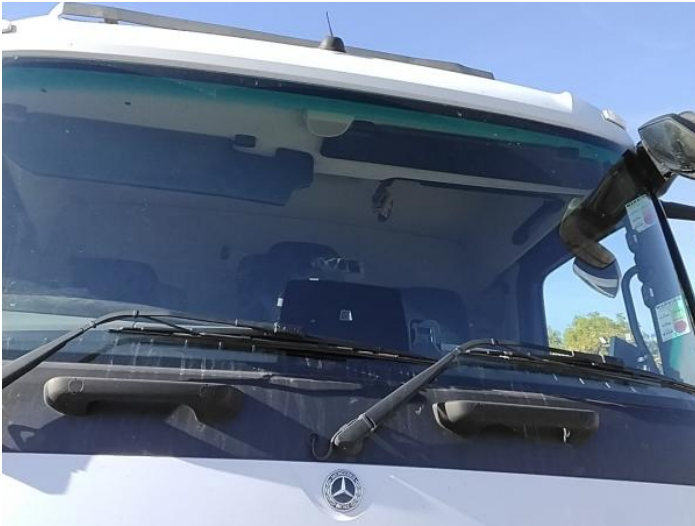
3: Screen Front  
Chipped  
UpTo 10mm

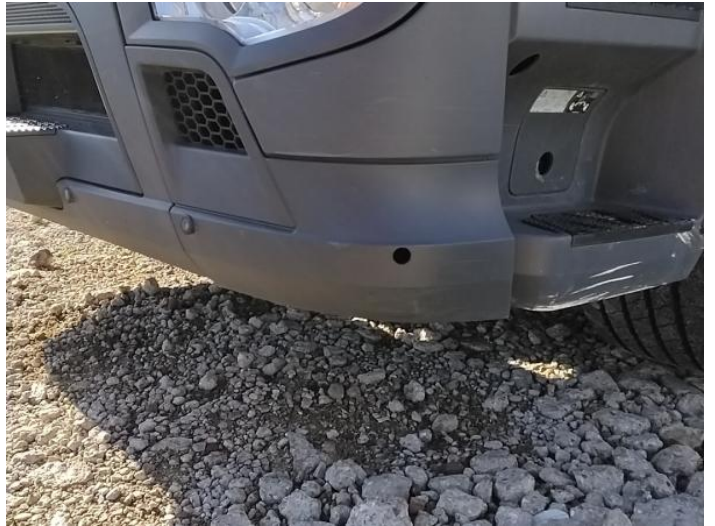
4: Bumper Front Moulding  
Scuffed (Unpainted)  
UpTo 100mm

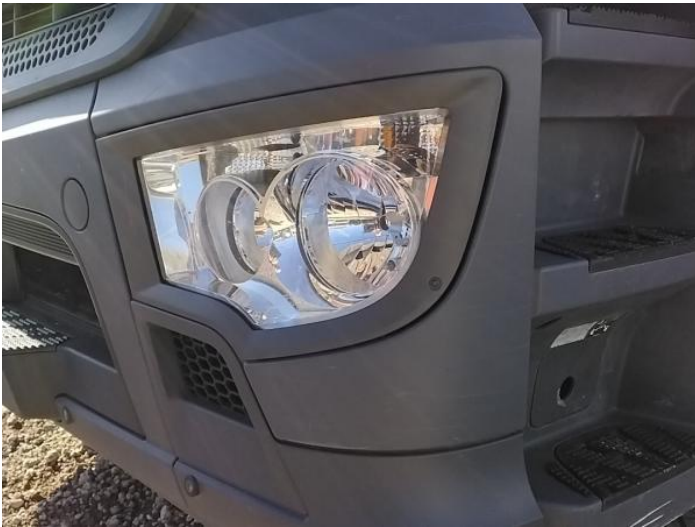
5: Fog Lamp Surround ns  
Scuffed (Unpainted)  
UpTo 100mm

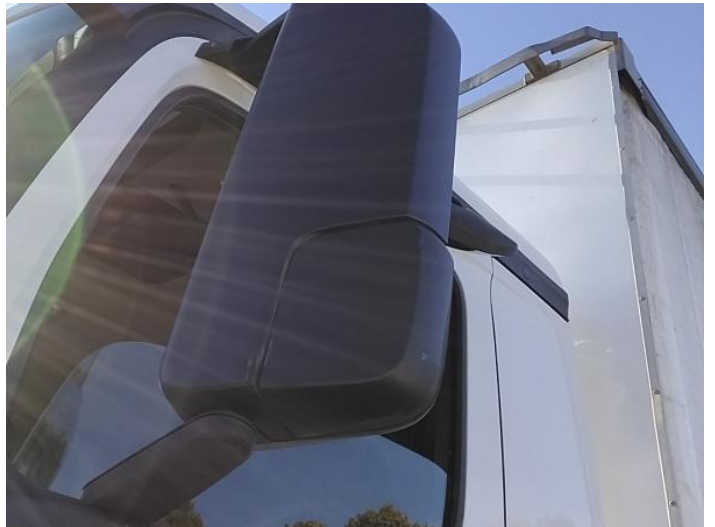
6: Door Mirror Assy nsf  
Scuffed (Unpainted)  
UpTo 100mm

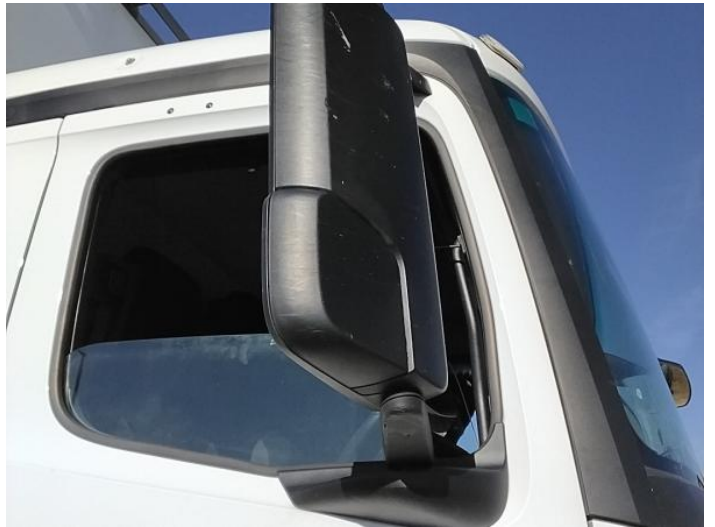
12: Door Mirror Assy osf  
Scuffed (Unpainted)  
UpTo 100mm
